RENOVATION OF A NATIONAL MONUMENT IN HUNGARY: THE KEREPESI GRANDSTAND

Keywords: renovation; strengthening; urban heritage; grandstand; reinforced concrete; CFRP sheet; concrete jacketing

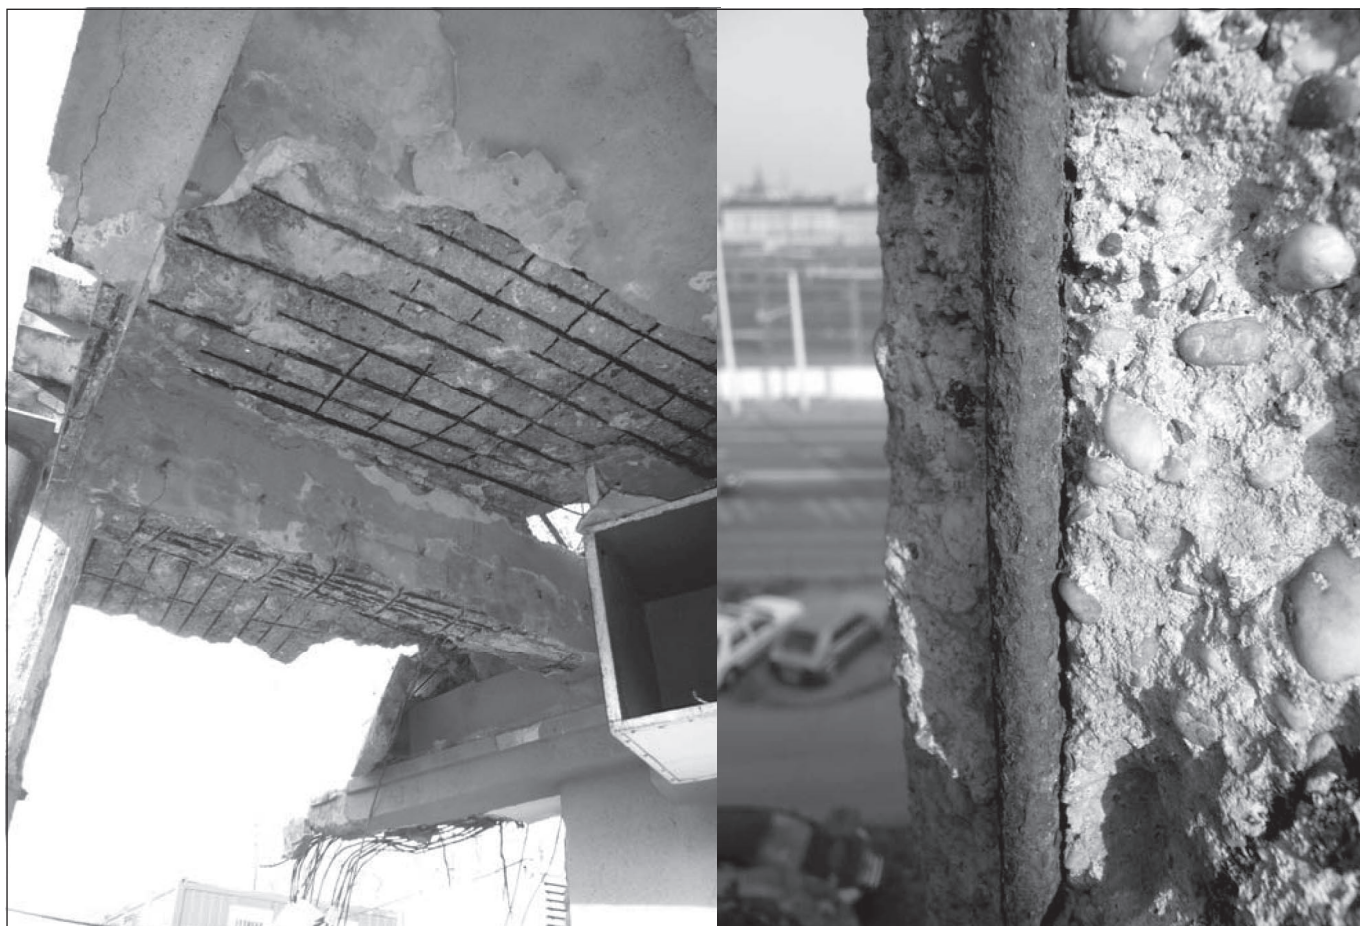
During the in-situ investigations, no visible sign of major damage or overloading of the load carrying structural members was detected (Bódi, Koris, Erdődi; 2002). However, cracks were spotted at the connections of the outside columns and cantilever beams. These cracks were mainly caused by tensile forces in the columns and the cantilever beams. Some cracks caused by shrinkage of the concrete were also detected in the secondary structures such as concrete barriers and banisters. Significant corrosion of reinforcing steel bars and the lack of concrete cover were observed on the outdoor structural members including columns, beams and slabs (Fig. 3). These problems were mainly caused by inappropriate waterproofing. No sign of surface corrosion or decrease of bond between steel

Fig. 3: Spalling of concrete cover and corrosion of steel bars at different structural elements

level to withstand the additional tensile forces. Cantilever beams on the roof were strengthened by bonded CFRP sheets (Fig. 7) to provide the necessary load bearing capacity (Sika Hungária, 1999). Cracks in the concrete structure were cleaned and injected with MAPEI Epojet resin before strengthening (Fig. 7). The concrete strength in the upper section of middle columns was insufficient therefore these columns were also strengthened by 50 mm concrete jacketing (Fig. 6). Former chimneys were cleaned with water jet and the holes were filled with concrete of C20-8/K quality. The stepped concrete slab was originally built with a thickness of 60 mm and the applied reinforcing steel inside the slab was only Ø5/120 mm. Due to these reasons the resistance of the slab is insufficient against concentrated live load. A force distribution layer was applied on this slab to provide the necessary resistance against concentrated loads. Shrinkage cracks were observed in the secondary concrete structures, such as curved stairs, concrete barriers and banisters. These cracks were again cleaned and injected with MAPEI Epojet resin to avoid further corrosion problems.
